Manhole Inspection Summary

Manhole # S69A1_001MH

Insp Date: **2/21/08 9:51 AM**

Location Address: **2205 Van Deman St.**

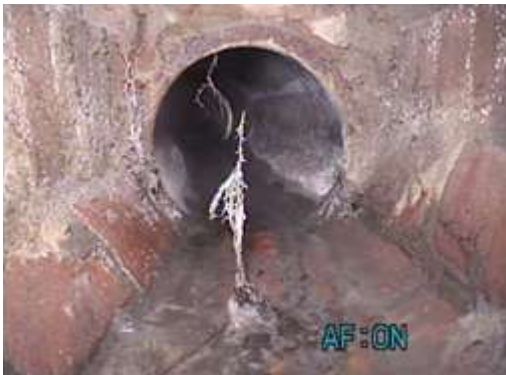
Defect 2

[rf] roots fine in channel

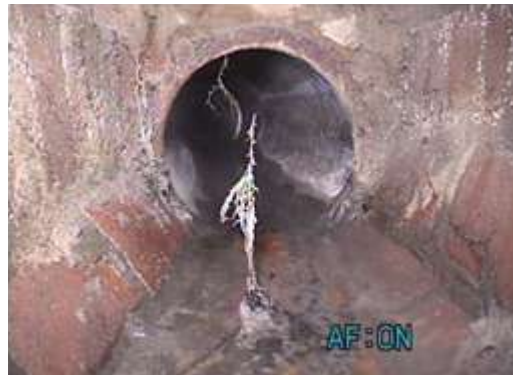
Defect 2

[rfj] roots fine joint 11 o'clock in the incoming 3 connection

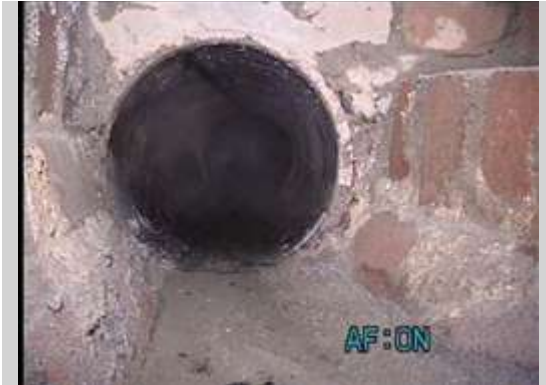
12 O'Clock Outflow

8 in. Circular Gravity Sewer
Pipe Out @ 12 O'Clock

Invert Depth: **5.08** (ft.) Flow Characteristics: **Slow**

Infiltration: **None** Pipe Seal Cond: **Sound**

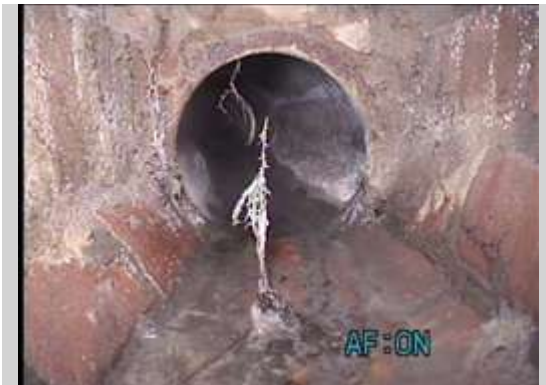
3 O'Clock Inflow

6 in. Circular Gravity Sewer
Pipe In @ 3 O'Clock

Invert Depth: **5.17** (ft.) Flow Characteristics: **Slow**

Infiltration: **None** Pipe Seal Cond: **Sound**
